Engineering Assessment of Flooding at Arroyo Doble Subdivision

Dr. David T Williams, P.E. (TX PE 80003), PhD, PH, DWRE

Dr. Gerald Blackler, P.E., PhD

Date: July 26th, 2018

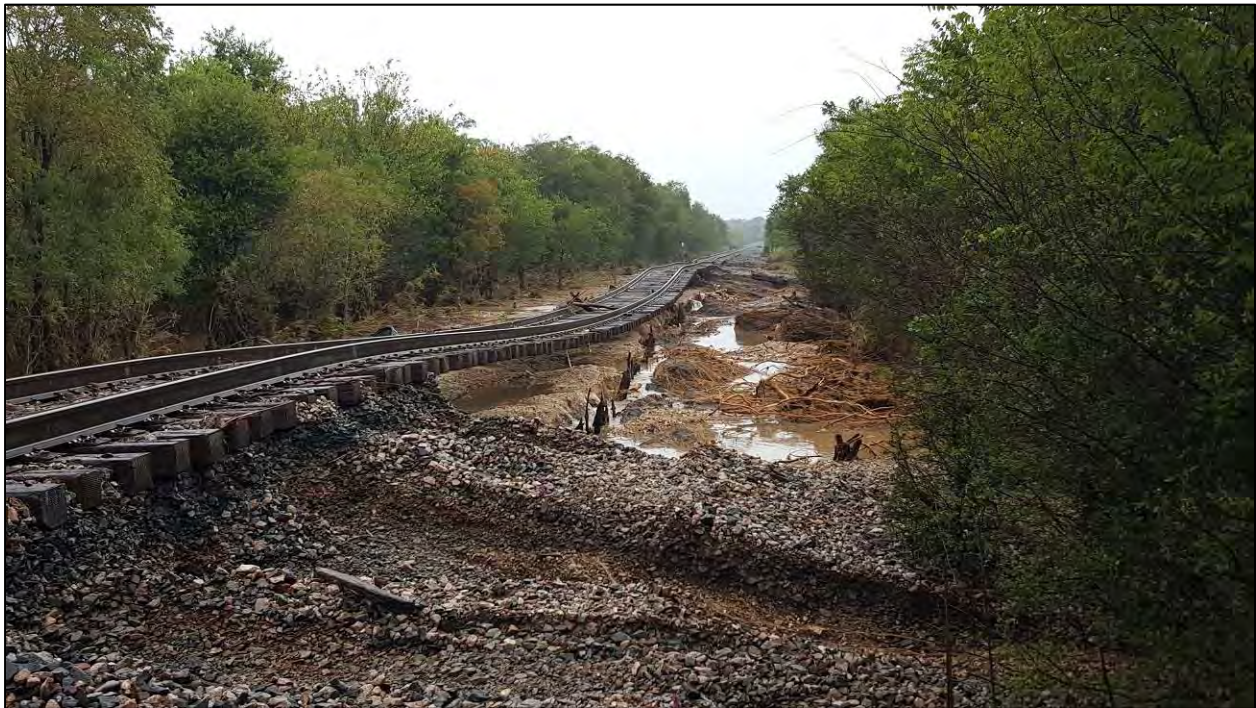
It does appear that there was a major failure in the past at this location. Based on review of aerial imagery, it appears that this location has been jeopardized and damaged from a previous rainfall event. In October 30 of 2013, there was an approximately 20-year rainfall event in the same drainage basin. Based on review of Google Earth imagery, it appears that a breach at the same location had occurred and was repaired by the UPRR staff.

Figure 1 - Picture of the breached railroad embankment provided by a resident of the Arroyo Doble neighborhood

According to the UPRR Engineering Track Maintenance Handbook (Revised in 2015) such a failure should have been reported and remedied, and a culvert or some drainage design should have been initiated immediately after the 2013 flood. Had this been done, it is possible that the 2015 flood event would not have produced such a large flood surge from the breached embankment and the damages to the neighborhood could have been significantly diminished.

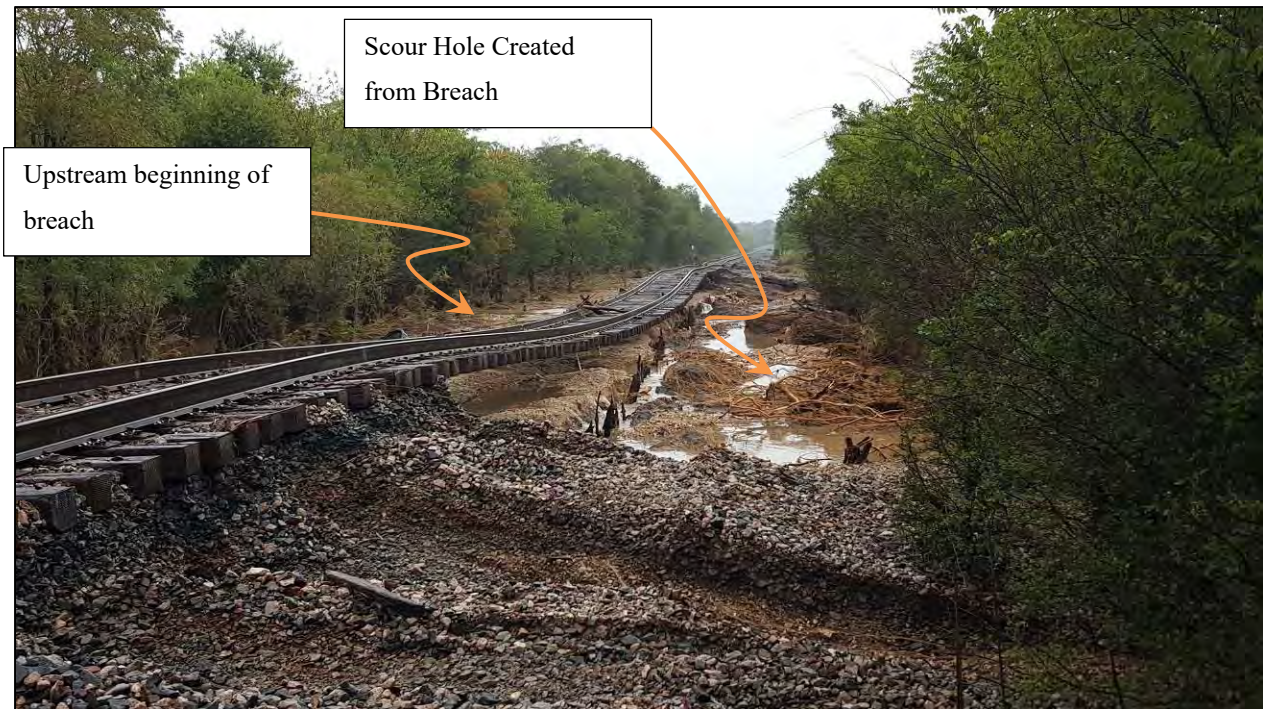
The main breach was estimated to be 100 feet long and assumed a scour hole approximately 6 feet deep. According to UPRR responses to questions (DEFENDANT’S OBJECTIONS AND ANSWERS TO PLAINTIFFS’ INTERROGATORIES, dated July 6, 2018),

there was a second, smaller breach of about 25 feet in width. This would make the total breach length, approximately 125 feet. Alternatively, it could be assumed that the smaller breach was less consequential (essentially bank sloughing) and that the large breach of 100 feet is the dominant breach mechanism. The assumption was made that the effective breach was ultimately 100 feet long and 6 feet deep.

Figure 6 - Image of Breach Location taken after the 2015 Event

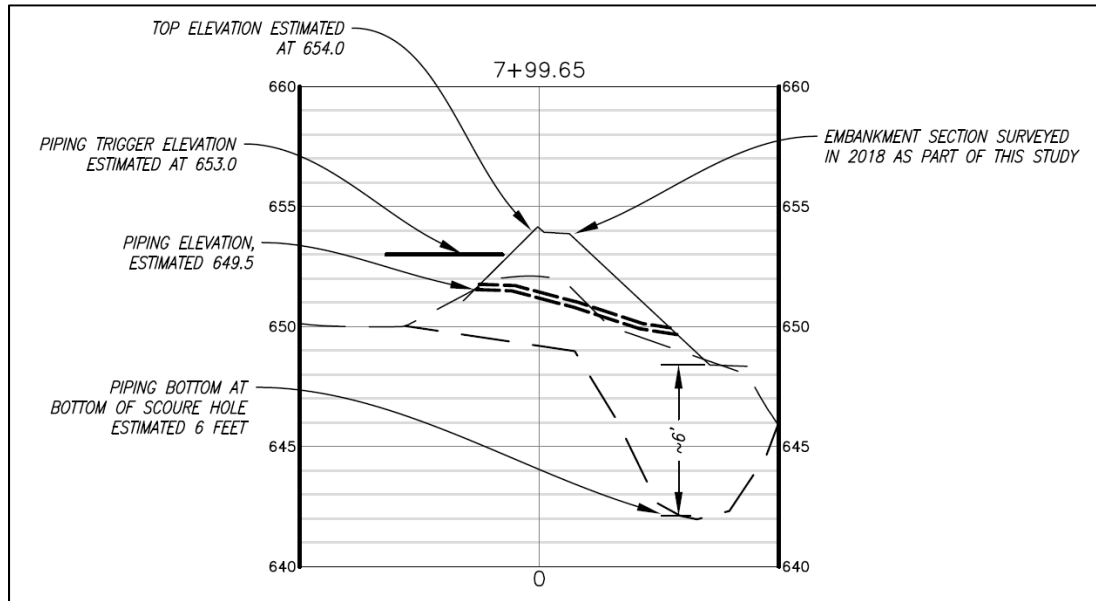
Figure 6 as an example). The Figure 7 is a railroad embankment cross section developed from the 2018 survey and the Austin GIS topography. The figure calls out the assumed parameters for the breach analysis.

Figure 7 - Cross Section of UPRR Embankment and Breach Parameters

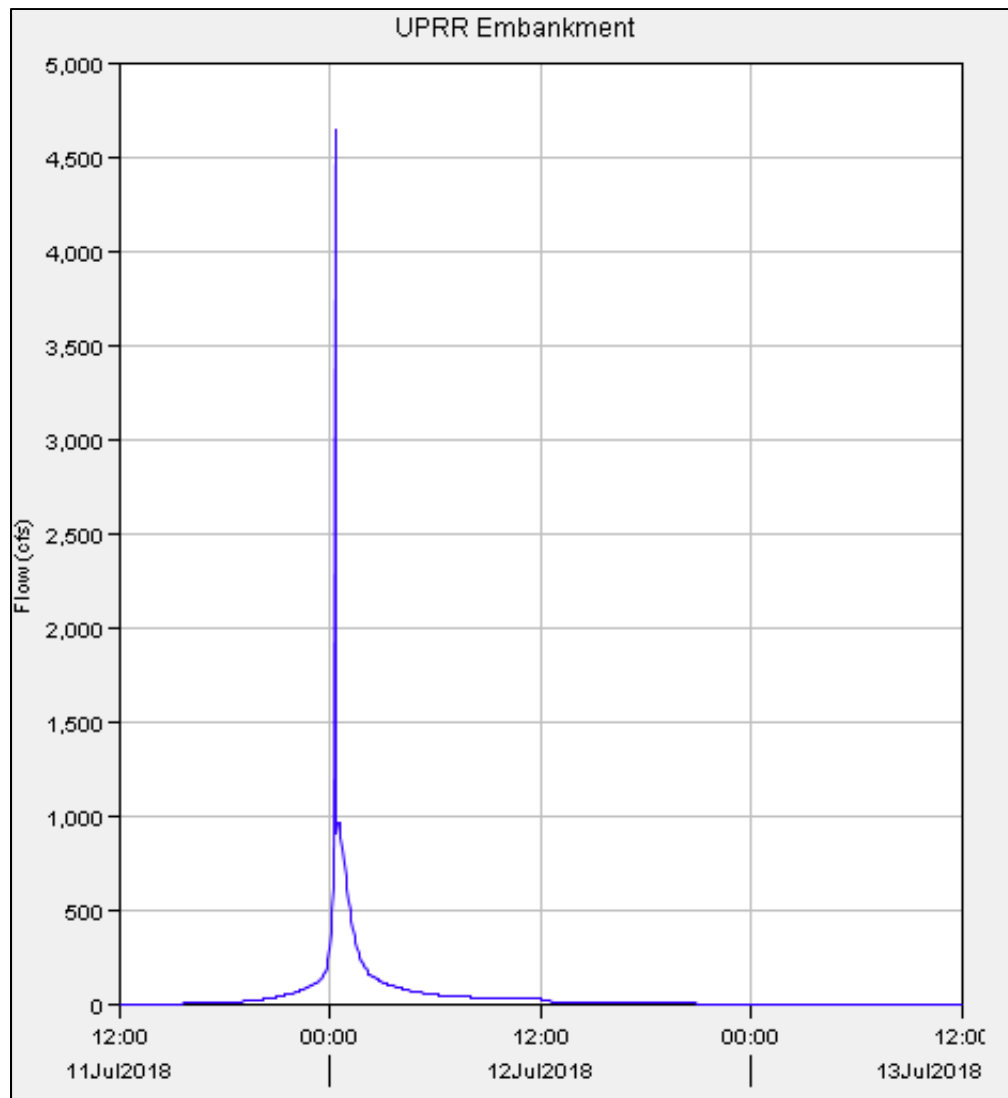
An additional breach progression was tested by adjusting the breach triggering method to be triggered at a specific time instead of at a specific elevation. This method was tested on the 24 hour and 6 hour piping scenario with the Sine Wave progression method. It was found that this combination produced the largest breach analysis peak flow of 4,637 cfs for the 24 hour storm and 7,169 for the 6 hour storm. The two breach hydrographs are presented below in Figures 9 and 10.

Figure 9 - Maximum Breach Hydrograph from a Piping Failure, with Time Triggered Beach, and a Sine Wave Progression under the 24-Hour Storm

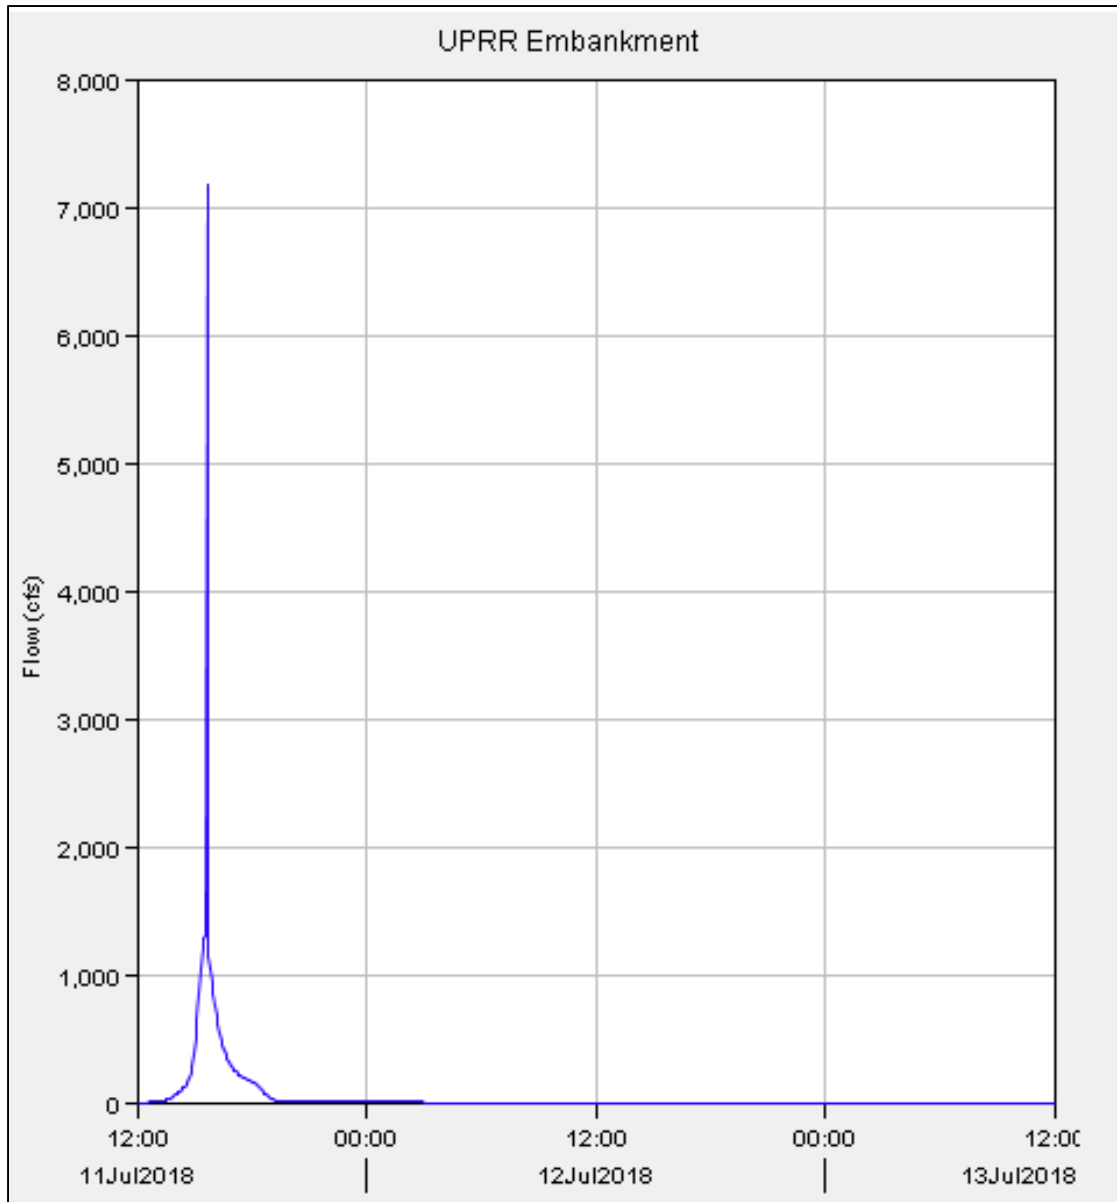
Figure 10 - Maximum Breach Hydrograph from a Piping Failure, with Time Triggered Beach, and a Sine Wave Progression under the 6 Hour Storm

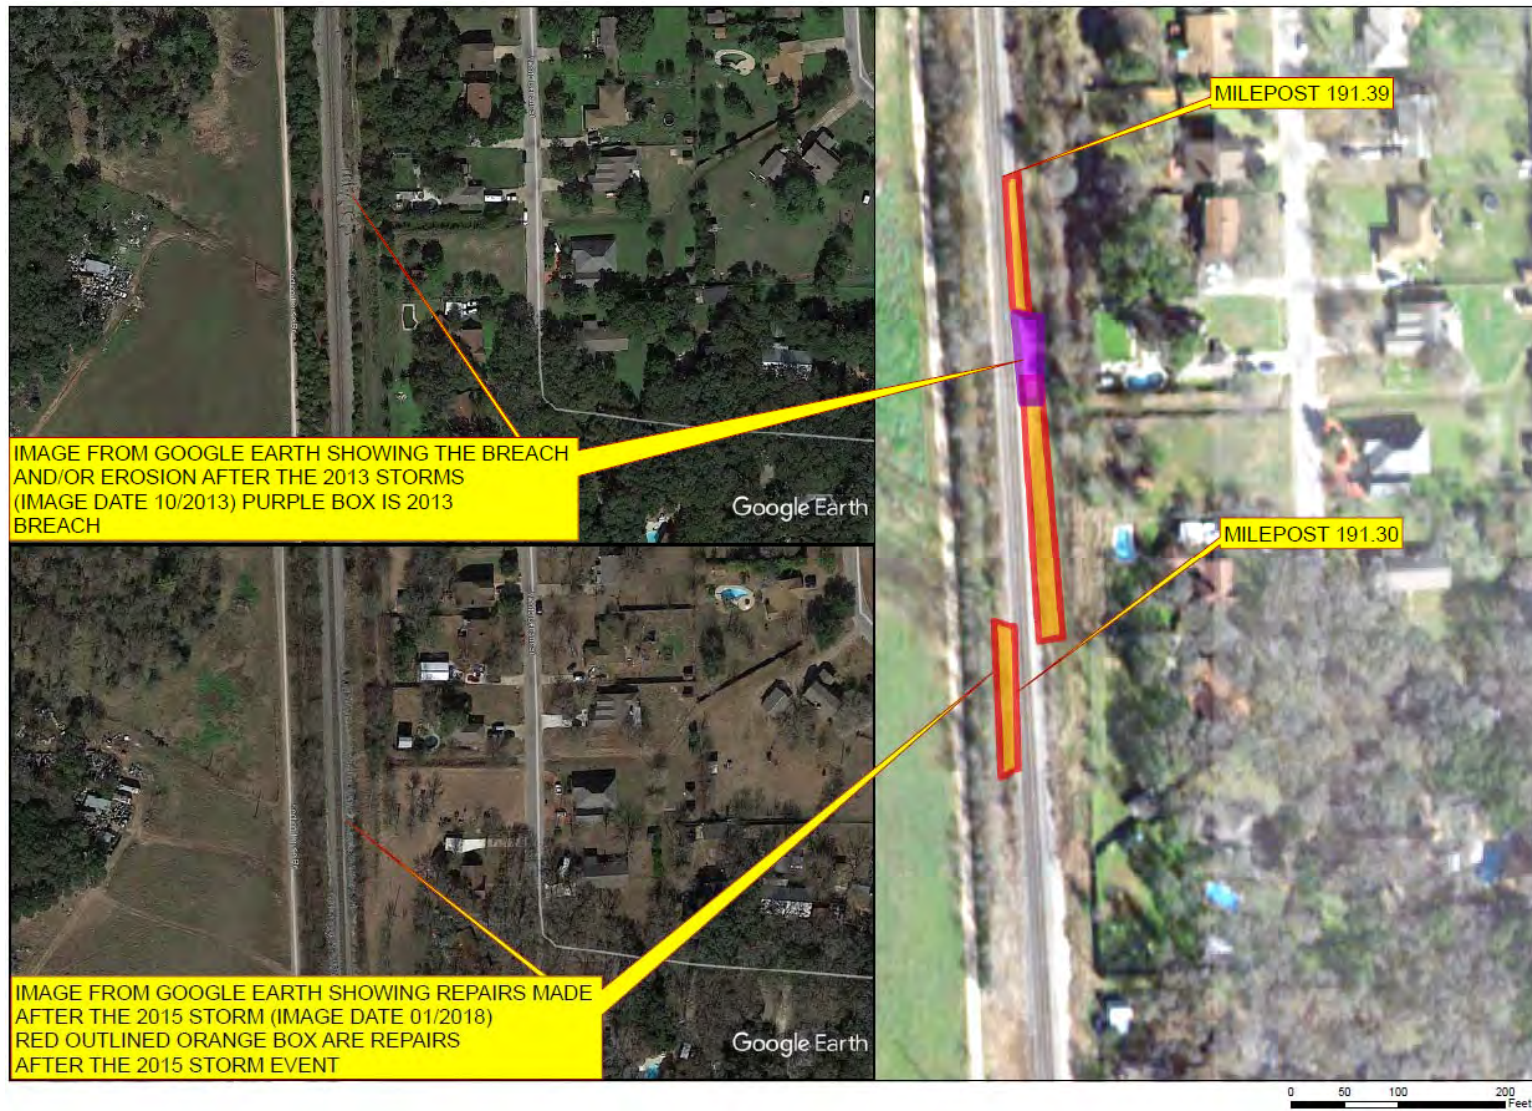
Based on review of aerial imagery (see Figure 18), it appears that this location has been damaged and there have been maintenance issue from rainfall events in the past. During an event in October of 2013, there was an approximately 20-year rainfall event in the same drainage basin. Based on review of Google Earth imagery, it appears that a breach in the same location had occurred in October 2013 and was subsequently repaired by UPRR.

The figure below presents the Google Earth imagery from 2013 and the most recent imagery of 2018, showing the extent of repairs made after the 2015 flood event.

Figure 18 - Images of Track Repairs in 2013 and after the 2015 Event

After the 2013 event, or possibly previous flood events, according to the UPRR Track Maintenance manual, UPRR should have installed a culvert or a series of culverts or possibly other drainage measures. Note that the 2015 event was a large event with an annual exceedance probability (AEP) of 0.4%, which correlates to a 1 in 250-year event. The two events in October that appeared to cause damage were smaller one in 2013, with an AEP of 5% (1 in 20 years). Had UPRR corrected the known drainage problems, it is possible that the 2015 flood event would not have breached the embankment and the damages to the neighborhood could have been significantly diminished.

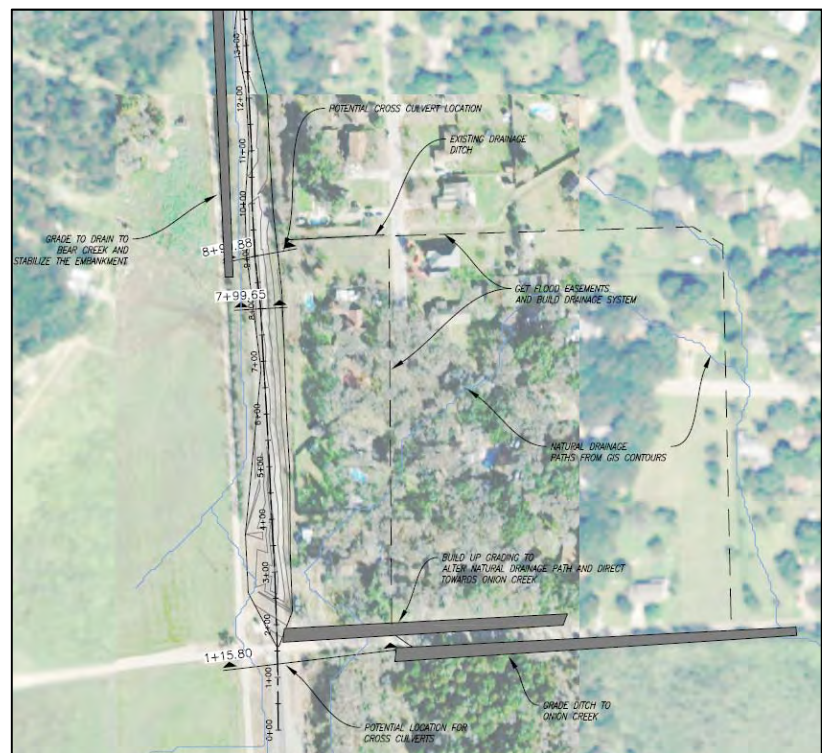
The natural drainage paths derived from the City of Austin's GIS contours take water through the neighborhood. A cursory review of the information indicates that water could be safely transported from upstream of the UPRR embankment to Onion

Creek and Bear Creek, although it would require a significant amount of work outside of UPRR's Right of Way (ROW).

The drainage to this site is approximately 200 acres and warrants a proper drainage study and drainage pathway to reduce the likelihood of the railroad embankment failing again in the future. If the railroad had established a culvert and drainage path before or even after the community was built, it is possible that some of the property damage could have been diminished and perhaps some not damaged at all, even for a large storm event such as the one that occurred in October of 2015. There appears to have been a failure in the past from an event that was significantly smaller. According to UPRR Engineering and Maintenance Manual, this failure should have prompted some type of corrective action to repair the drainage deficiencies. If an entity wants to design and construct a more robust drainage solution, it appears that this could be possible; however, much of the work required for a drainage solution would be outside of the UPRR ROW. UPRR could install a series of cross culverts to reduce the likelihood of an embankment failure occurring in the future.
